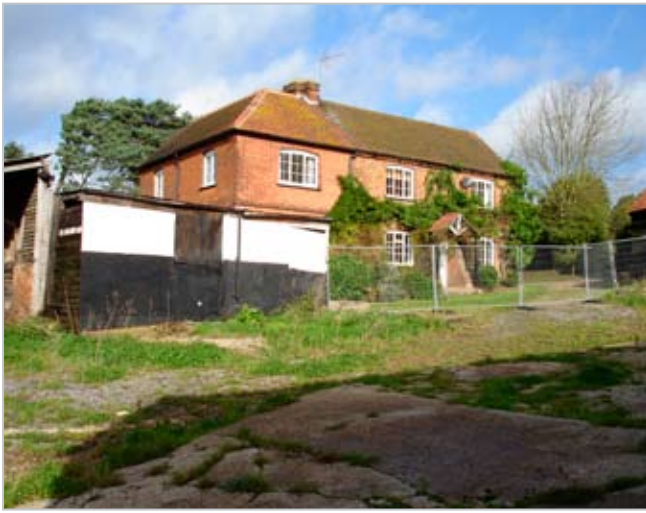
Photo 1

The buildings with the highest potential to support roosting bats by virtue of appearing to possess reasonably well insulated roof voids were Copse House (Photo 1), Dairy and Farm Cottages (Photo 2), and the Stable Flat (Photo 12). As referred to previously, Dairy and Farm Cottages were not be inspected during the current survey. The Stable Flat was not in residential occupancy at the time and was inspected internally. It was not possible, however, to enter the roof void as there was no loft hatch on my first visit. The roof structures of all four residential buildings appeared (from limited external inspection) to be in good condition, and the presence of bats is only a theoretical possibility that reflects the previous finding that bats are active and using the nearby barn. Further survey work is recommended to verify bat presence in any residential building scheduled for demolition or renovation that could effect the roof space and/or any cellar (see below).

For the residential buildings where bat presence is a theoretical potential, internal inspections of loft voids and cellars should be completed in the first instance (can be undertaken virtually any time of year provided safe access is made available). If signs of bat roosting are found then a bat activity survey will be required (as outlined above) and a suitable mitigation strategy developed in consultation with English Nature to support an application to the RDS for a development licence to enable the works to proceed lawfully. The scope of the mitigation required will be entirely dependent upon the findings of the bat activity survey, but could result in the need for an alternative bat roost facility to be incorporated in the new/renovated building, and timing restrictions

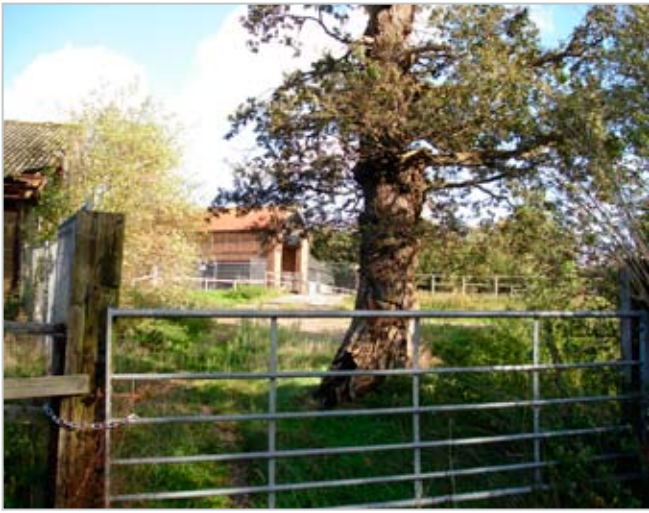
Photo 7

A single mature oak tree in poor physical condition with a number of splits, holes and crevices occurs just beyond the site boundary to the east (Photo 7). It is reported here as it has potential to support roosting bats and may be indirectly susceptible to damage as a result of construction as its canopy and root zone overlap into the site boundary. It is of note that no signs of roosting bat use of the tree were recorded at the time of survey, but this cannot be taken to discount future use of the tree.

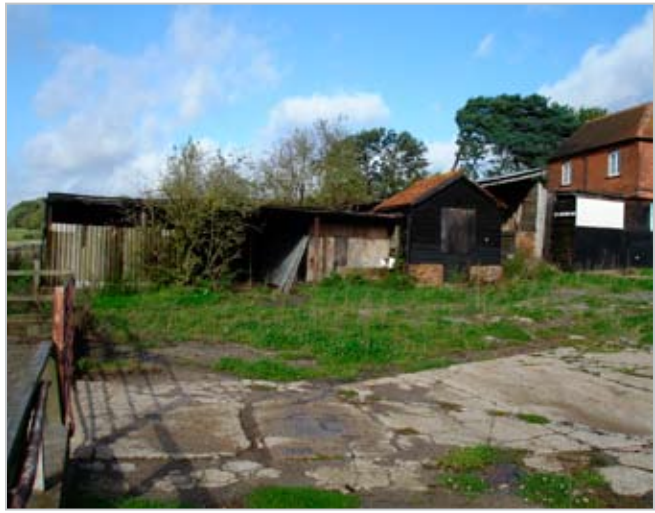
Photo 8

The buildings were highly variable in terms of their condition, construction, general state of repair. The majority were in a dilapidated state and were too open and draughty to be of significant value to roosting bats (e.g. Photos 8 & 9). A low number (< 5 no. in total) scattered bat droppings consistent in size and shape with pipistrelle bat were found on surfaces within the lean-to building adjoining the old barn with the red clay tiled roof (Photo 10), and in the barn that adjoins and is physically linked internally to the lean-to (Photo 11). Both buildings appear rather too open and draughty to be of significant value to roosting bats, and large piles bat droppings indicative of the presence of a large or important bat roost were not found. The dropping evidence is indicative of only occasional use of the buildings by an individual bat, possibly for the purposes of feeding only.

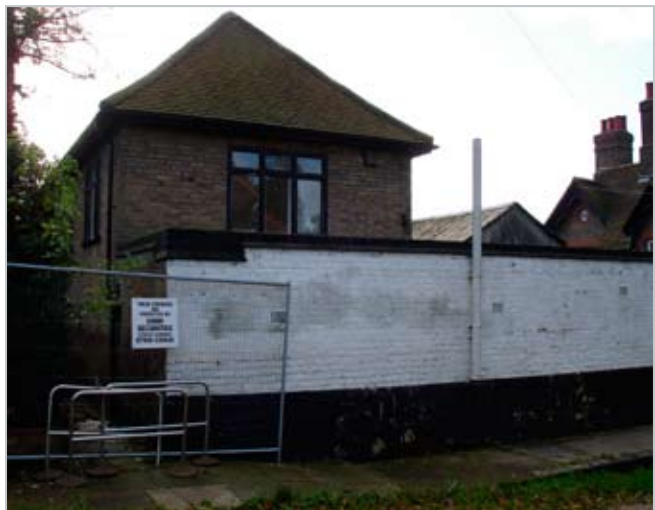
Photo 12

An opening into the Stable Flat roof ceiling was created to enable me to inspect the roof void of this building on 25<sup>th</sup> November 2005. A full internal inspection was completed, and no sign of bat activity or roosting was found. On this basis, I do not believe that there are currently any ecological reasons why the Stable Flat cannot be demolished subject to contractors taking care to keep a watching brief for bat presence, and stopping work and informing English Nature if a bat is found.
